NATURAL PROPAGATION AND HABITAT IMPROVEMENT

FINAL AND ANNUAL REPORTS, 1982/1983

FISH/WASH CREEK HABITAT IMPROVEMENT
ANNUAL REPORT, 1983

FISH/WASH CREEK HABITAT IMPROVEMENT
FY '83 ACCOMPLISHMENT REPORT

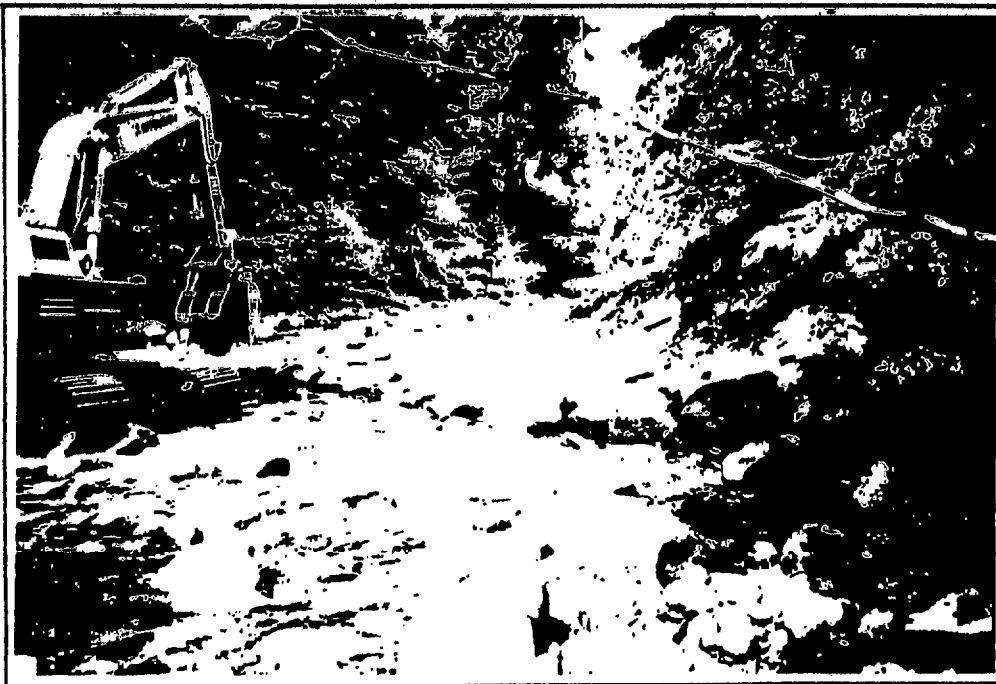
Backhoe constructing primary row of boulders of arm of boulder berm. Largest boulders in the reach of stream are used for this row.

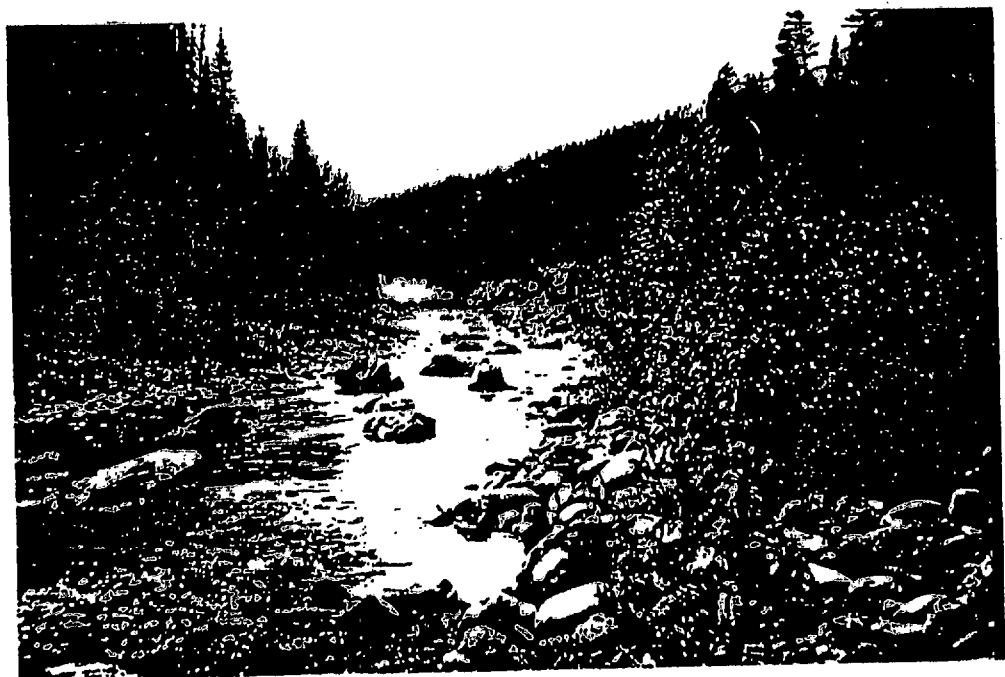
The addition of boulders have created more instream habitat for Andromous Fish fingerlings.
